STS-107 POST LAUNCH FILM REVIEW
KSC Photo/Video Analysis Team
17 January 2003

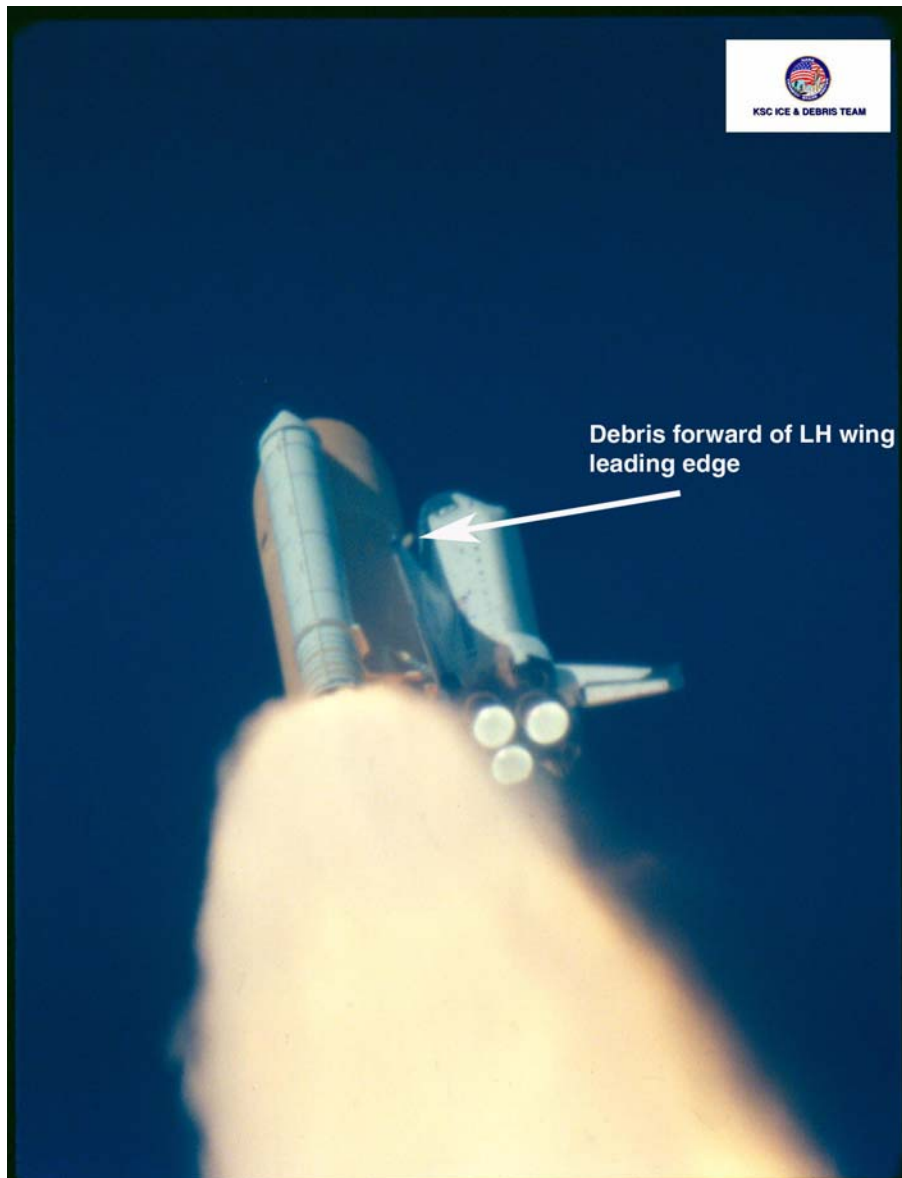
Photo 1.

1. At approximately 80-84 seconds (accurate timing off of film will be done tomorrow) after T-0 a large piece of debris is observed striking the underside (-Z) of the LH wing of the orbiter. The debris appears to originate from the area of the -Y bipod attach point on the external tank. (E-208, E-212) No damage to orbiter TPS is apparent. Further analysis will continue.
